HALLS POND DAM

CT 00388

PHASE I INSPECTION REPORT
NATIONAL DAM INSPECTION PROGRAM

Identification No.:	CT 00388 CT 00598
Name of Dam:	Halls Pond Dam
Town:	Eastford
County and State:	Windham, Connecticut
Stream:	Slovik Brook
Date of Inspection:	27 February, 1981

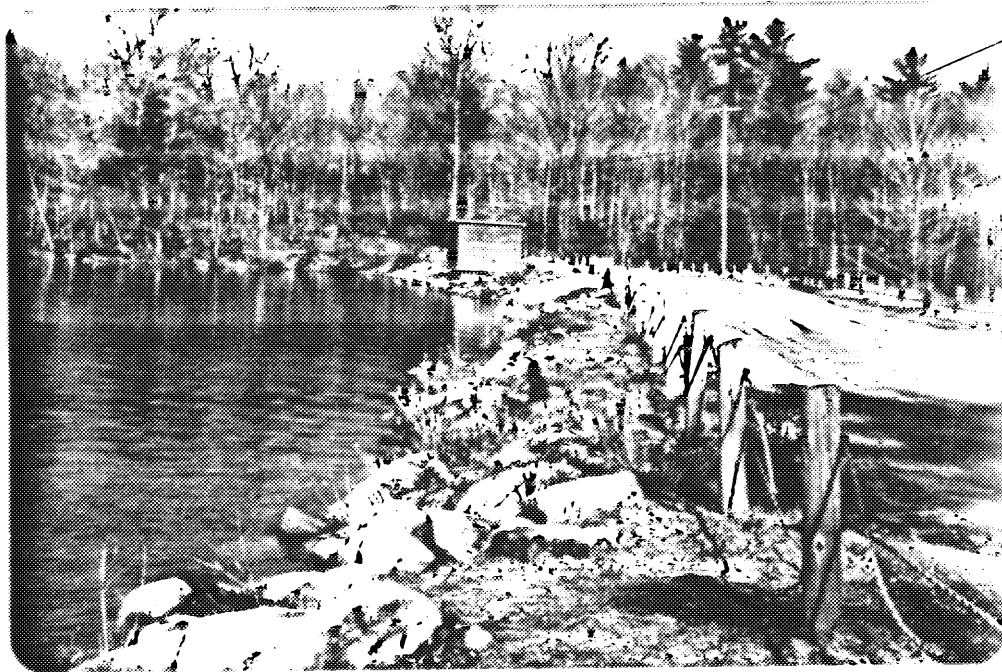
- 1. Upstream Face - The dumped rock fill is missing in some areas. There is minor brush growth, most of which has been trimmed as shown in Photos C1-1 and C1-6. There has been some erosion just south of the spillway, caused by storm runoff from the roadway.
- 2. Crest - The crest consists of Kennerson Reservoir Road which is an oiled gravel Town road. The road is in good condition, but the wire rope guide rail on the west side has been partially removed at the south end as shown in Photo C1-1.
- 3. Downstream Face - The downstream face is grass covered with some brush growth as shown in Photos C1-2 and C1-3. No seepage was observed.

C1-1 UPSTREAM SLOPE

1. Repair guide rail at south end of north dam.
2. Construct paved ditch to carry road water at spillway.
3. Paint all steel in gate house and repair lock on door.
4. Repair riprap at both dams.
5. Check operation of gate on a regular basis.

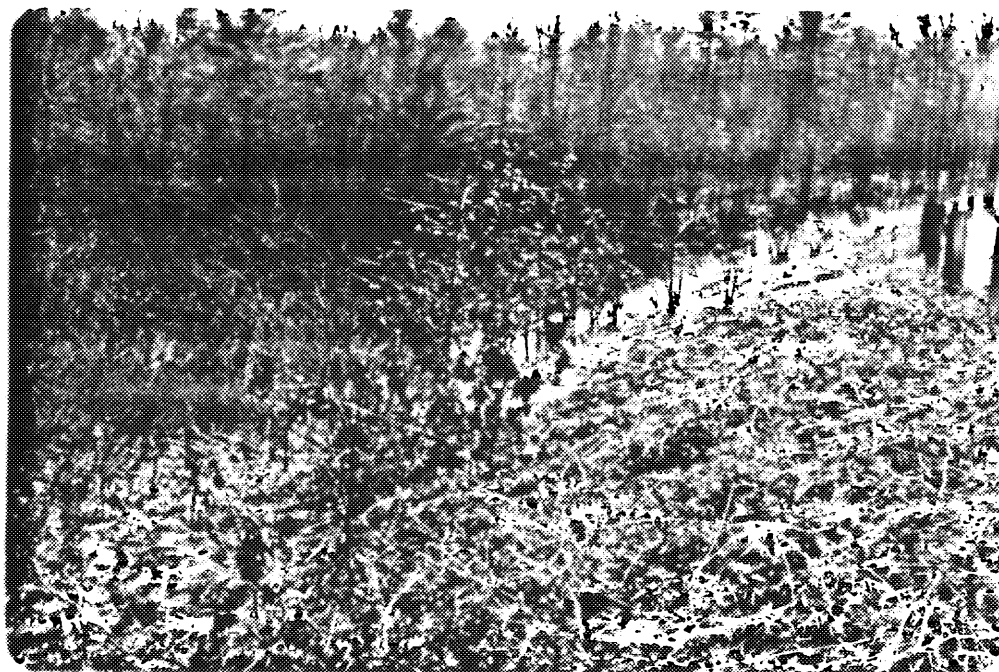
C1-2 DOWNSTREAM SLOPE

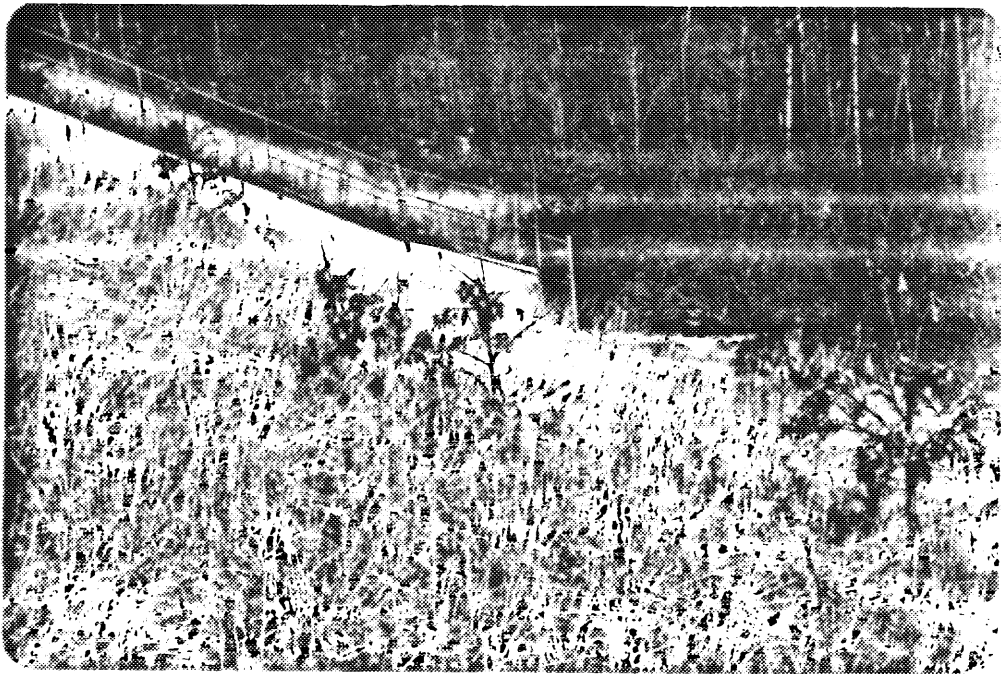
C1-3 DOWNSTREAM SLOPE AT SPILLWAY

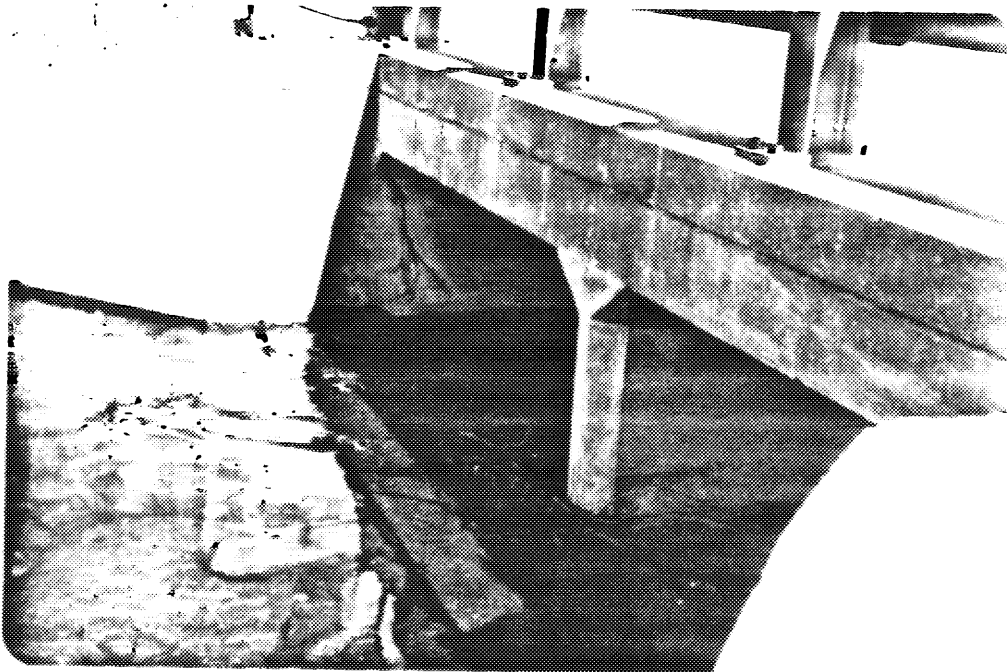
1. Spillway - Twin 9'x3.3' cast-in-place concrete box culverts constructed in 1968 form the spillway with a concrete channel on a 2H:1V slope for an outlet channel. Photos C1-4 and C1-5 show the spillway and channel. The spillway is in good condition except for a crack at the wingwall at the northwest corner as shown in Photo C1-4. This crack should be investigated further.

C1-4 UPSTREAM END OF SPILLWAY

- a. Investigate areas of seepage in the downstream face of the south dam to determine if repairs are warranted.
- b. Investigate the crack in the box culvert spillway at the northwest corner to determine if repairs are warranted.

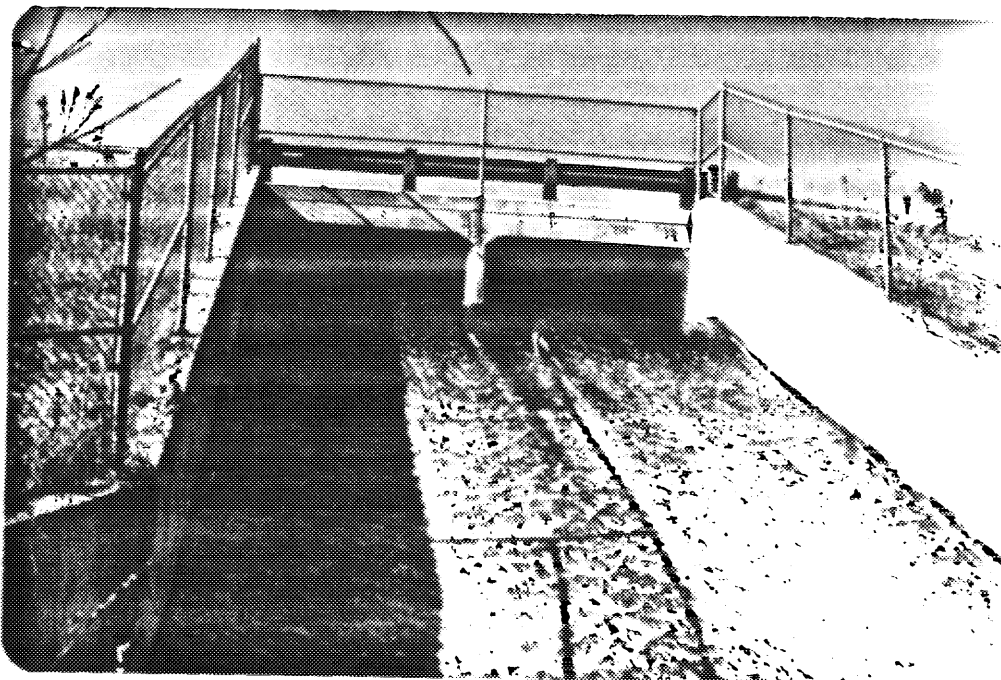
C1-5 DOWNSTREAM END OF SPILLWAY

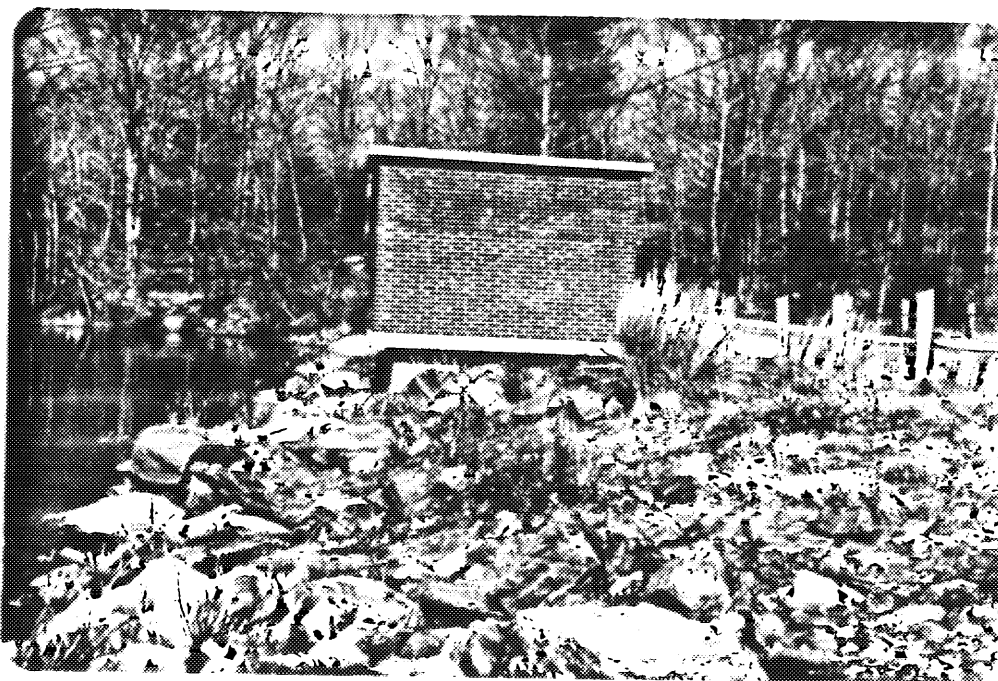
C1-6 GATEHOUSE

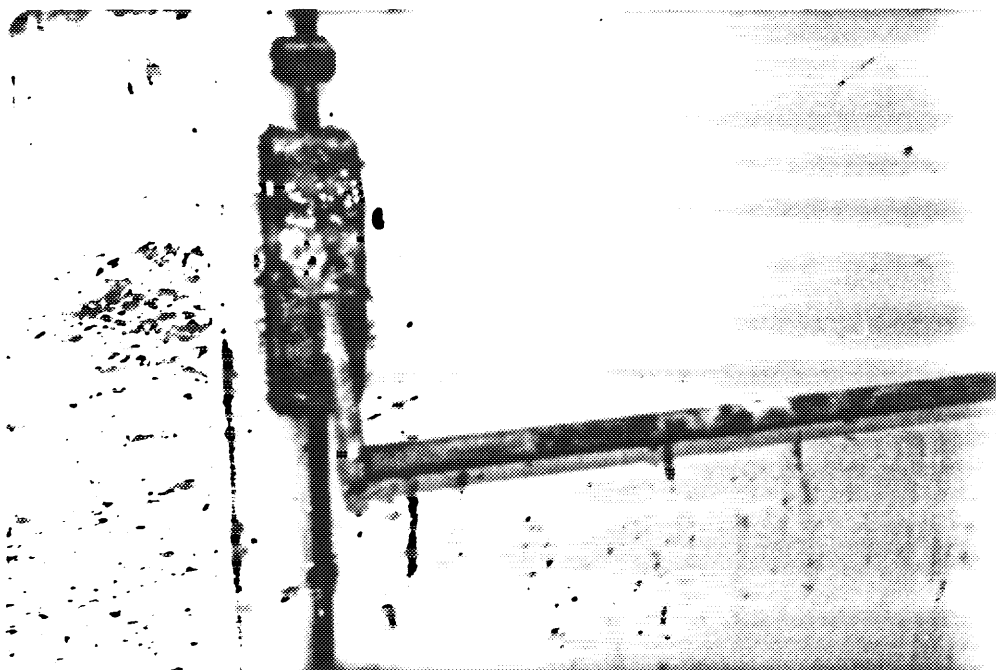
C1-7 GATEHOUSE DOOR LATCH

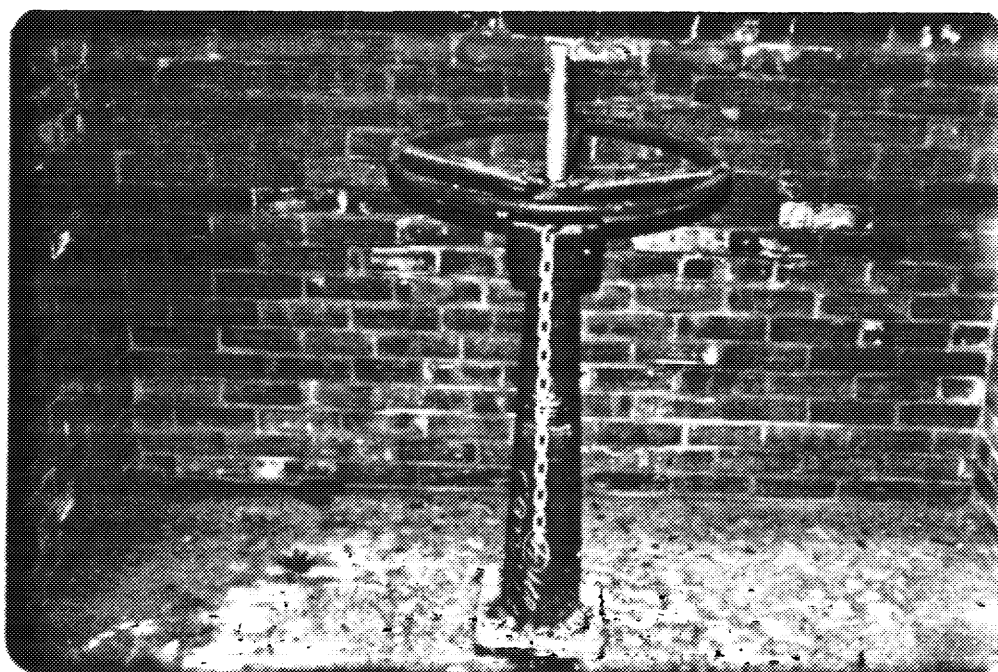
C1-8 GATE CONTROL WHEEL

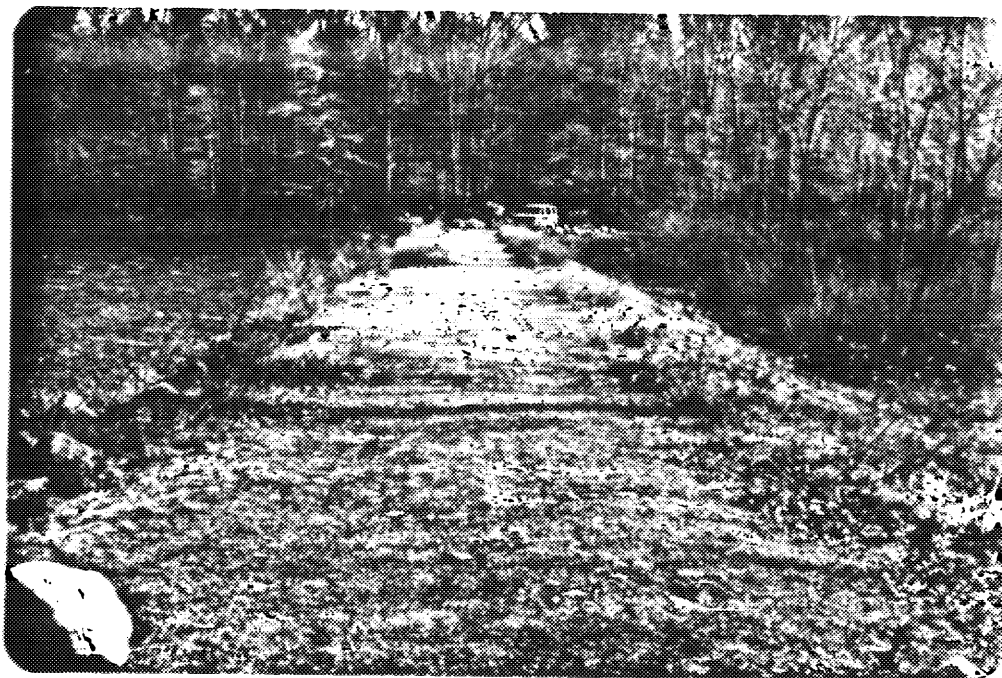
2. Crest - The crest is a gravel road in good condition as shown in Photo C2-2.

C2-2 DIKE CREST

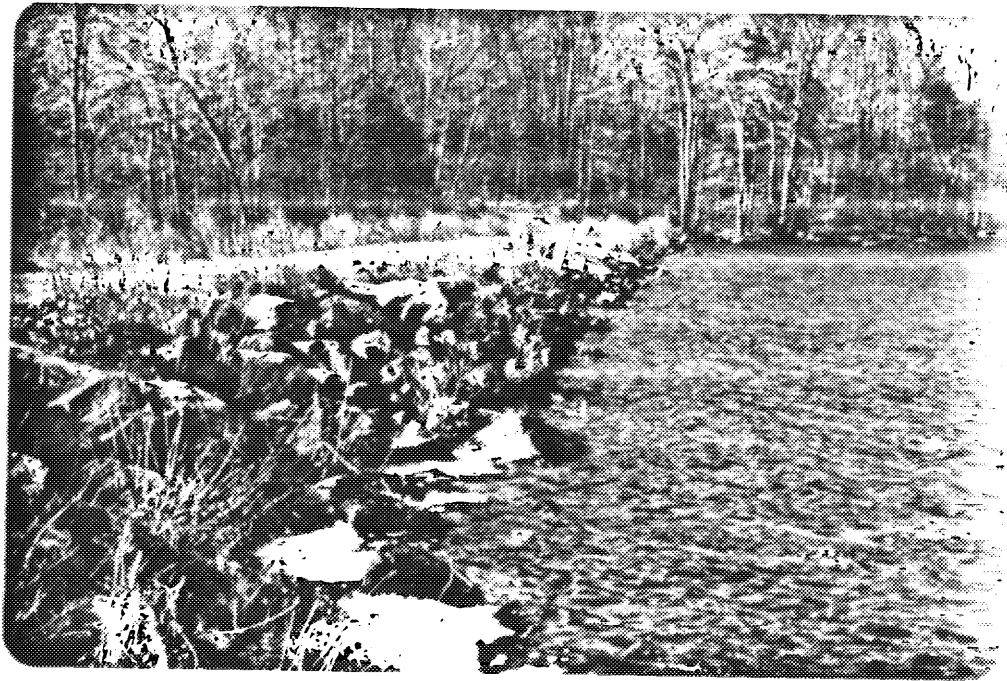
- 1. Upstream Face - The upstream face has dumped rock fill which is missing in some areas as shown in Photos C2-3 and C2-4. There is minor erosion from wave action.

C2-3 UPSTREAM FACE

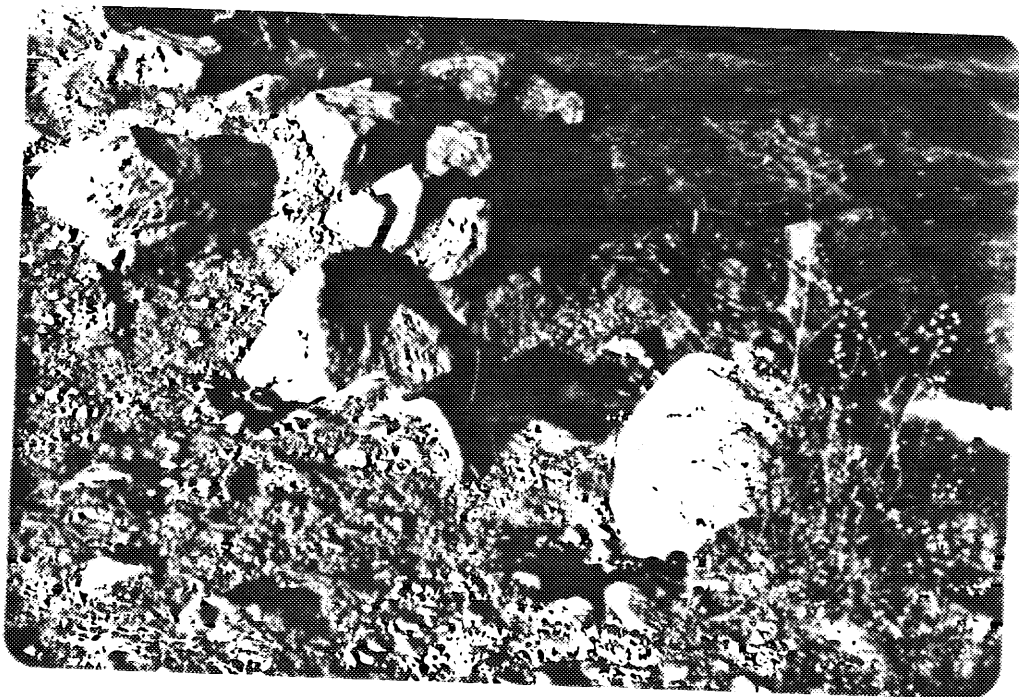
C2-4 MISSING RIPRAP ON UPSTREAM FACE

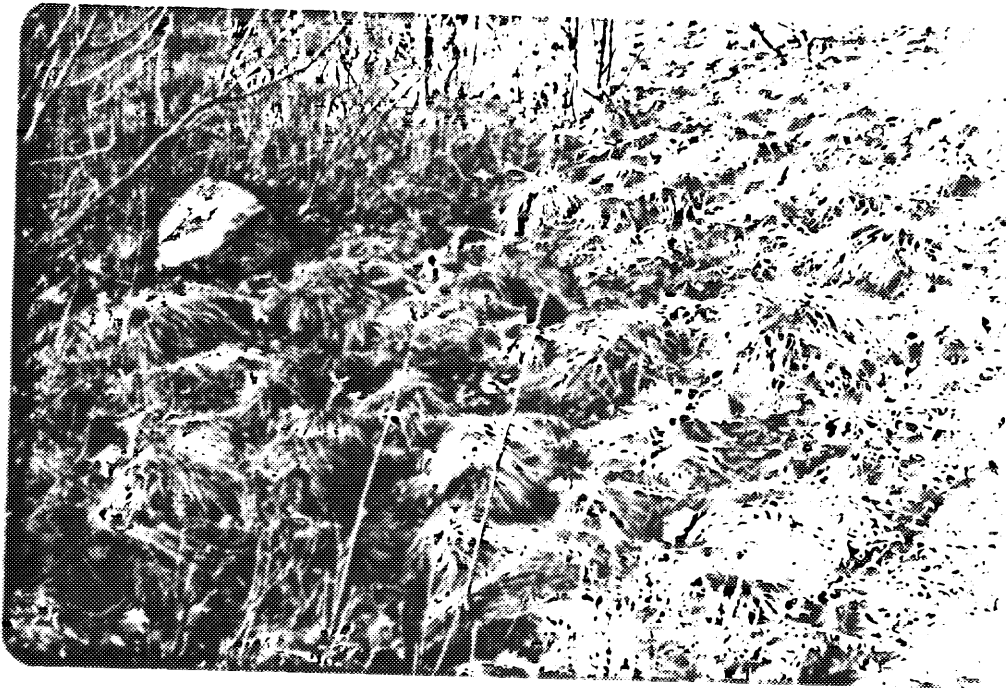
C2-6 SEEPAGE ON DOWNSTREAM FACE

It is recommended that an engineer study the seepage at the south dam and that the owner perform any corrective measures required. This should be done within one year, and the remedial measures detailed in Section 7 should be accomplished within one year.
